**CONSENT ORDER
ISSUED UNDER THE
WATER POLLUTION CONTROL ACT
WEST VIRGINIA CODE, CHAPTER 22, ARTICLE 11**

TO: MarkWest Liberty Midstream & Resources, L.L.C. DATE: March 28, 2019
Gregory Bezdek, SVP, NE Region
4600 J Barry Ct. Ste 500
Canonsburg, PA 15317 ORDER NO.: 8945

MARKWEST LIBERTY MIDSTREAM & RESOURCES, L.L.C, WVR311004, Sherwood to Mobley
20" NGL, 8/22 & 8/23/2018

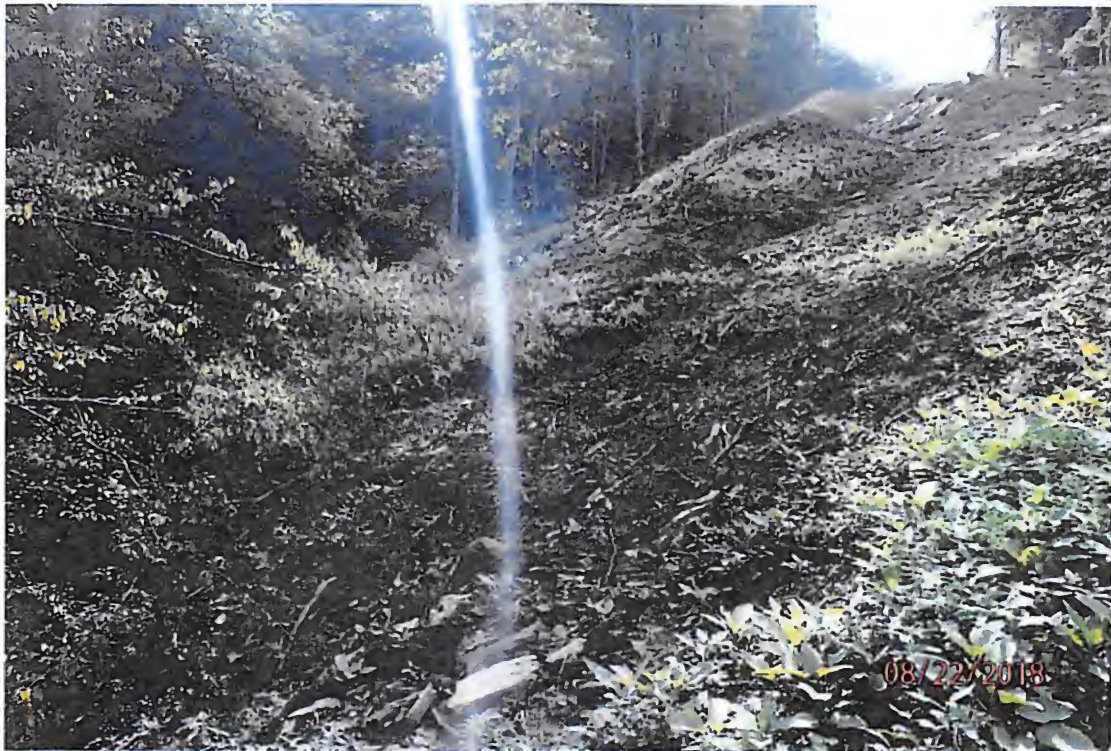
Project area adjacent to 145+00 where sediment laden water is leaving the site and no BMP is indicated on the approved SWPPP.

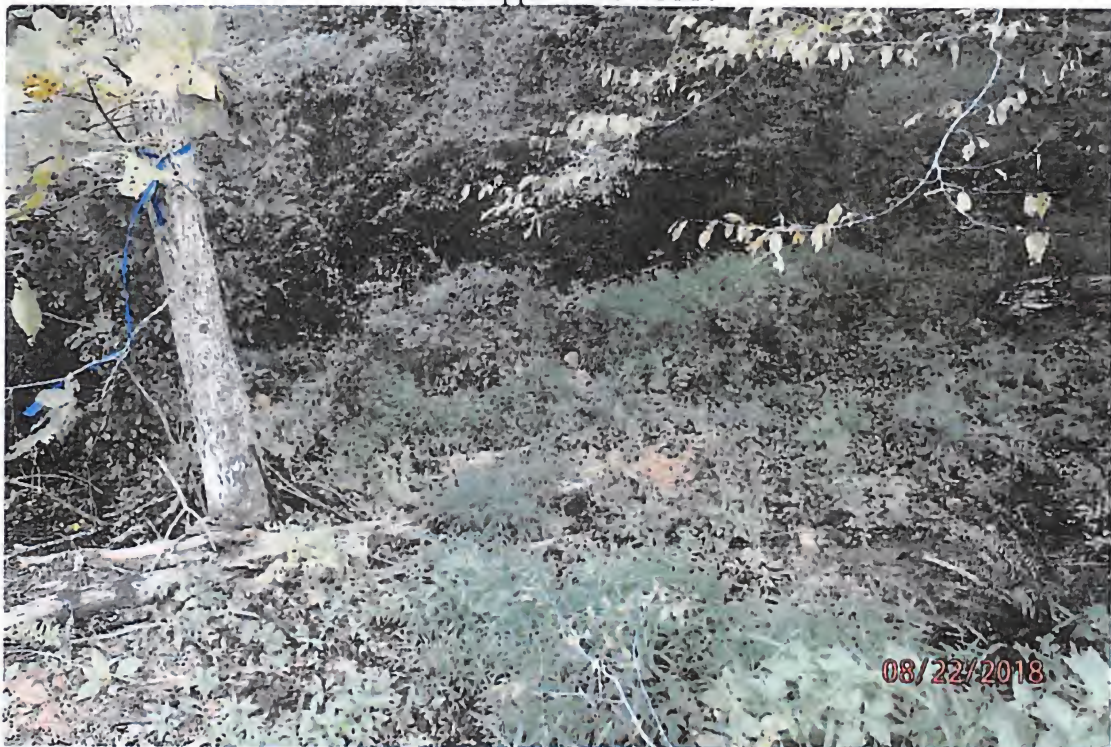
Offsite sediment deposits originating from the above pictured area.

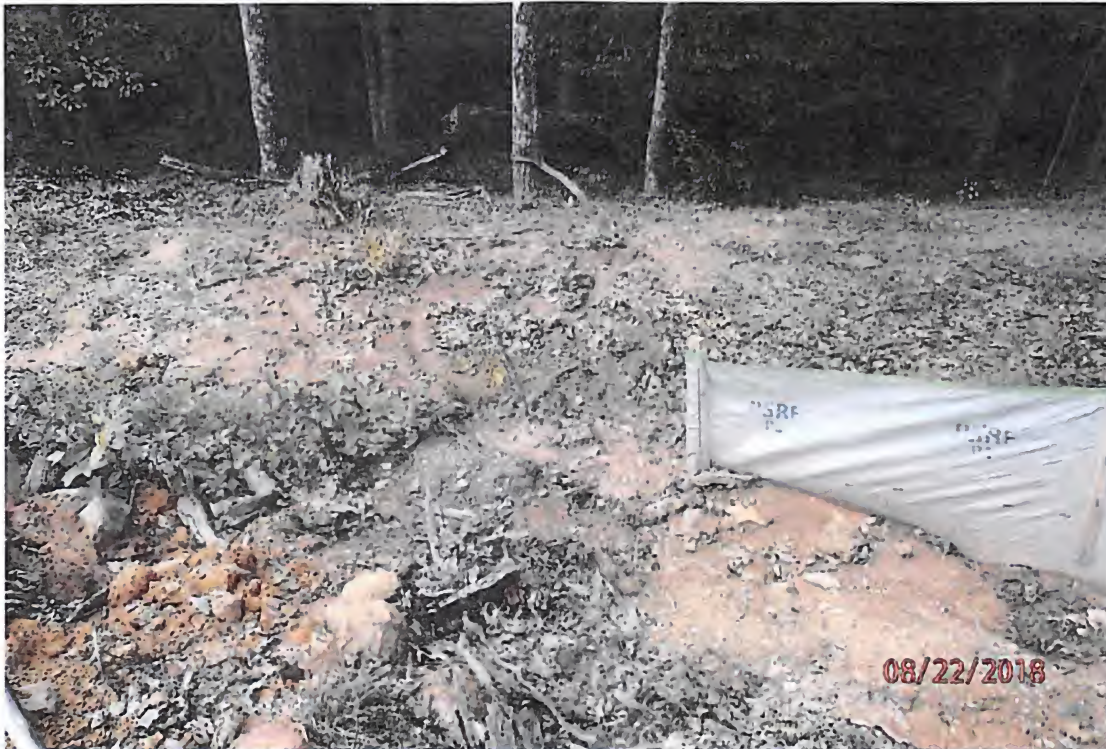
Installed perimeter control that needs to be extended in the Flint Run watershed.

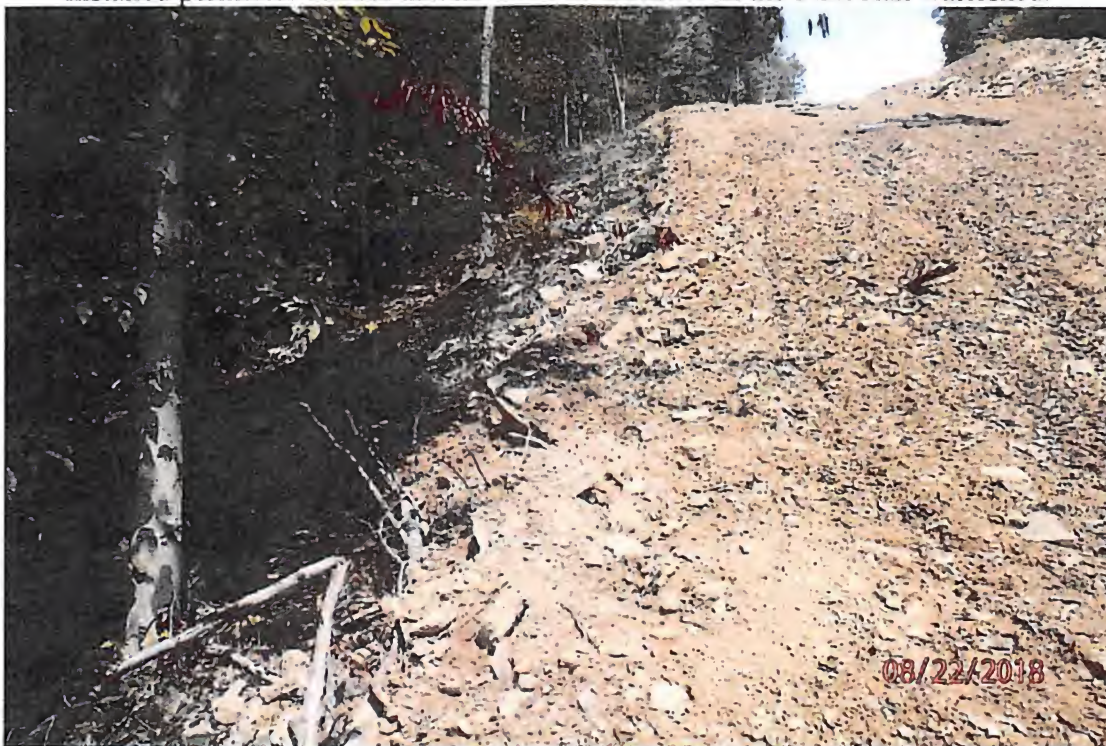
Installed perimeter control that needs to be extended adjacent to 287+95.

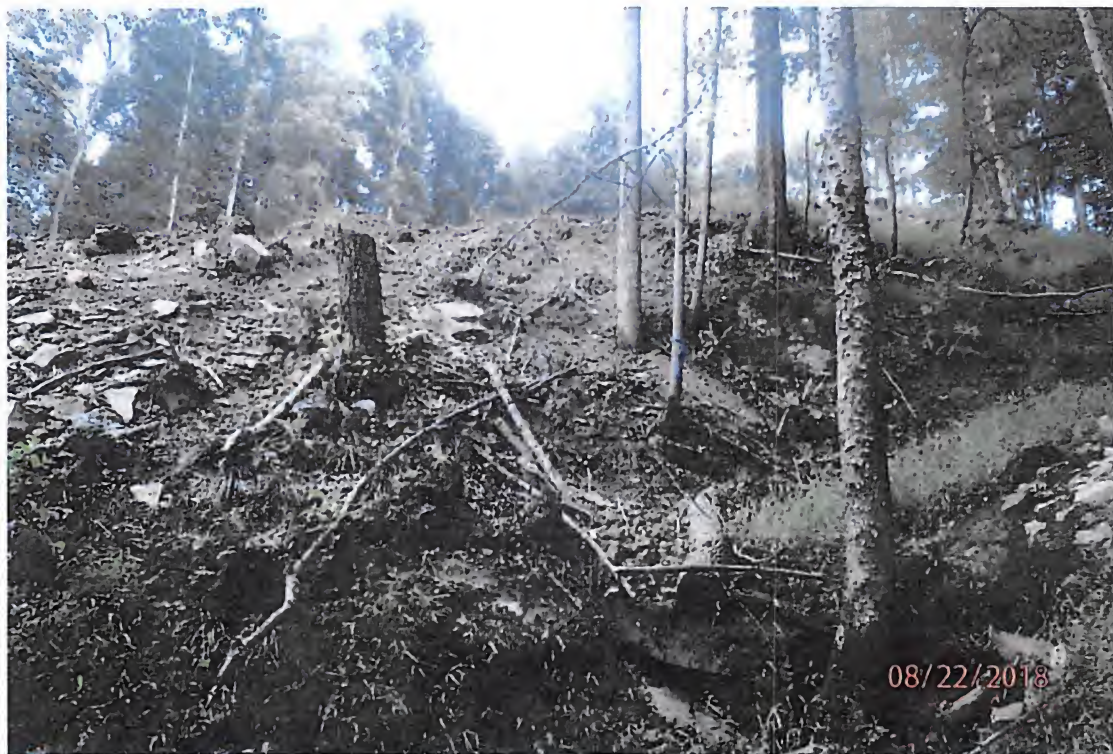
Project area adjacent to 272+00 where sediment laden water is leaving the site and no BMP is indicated on the approved SWPPP.

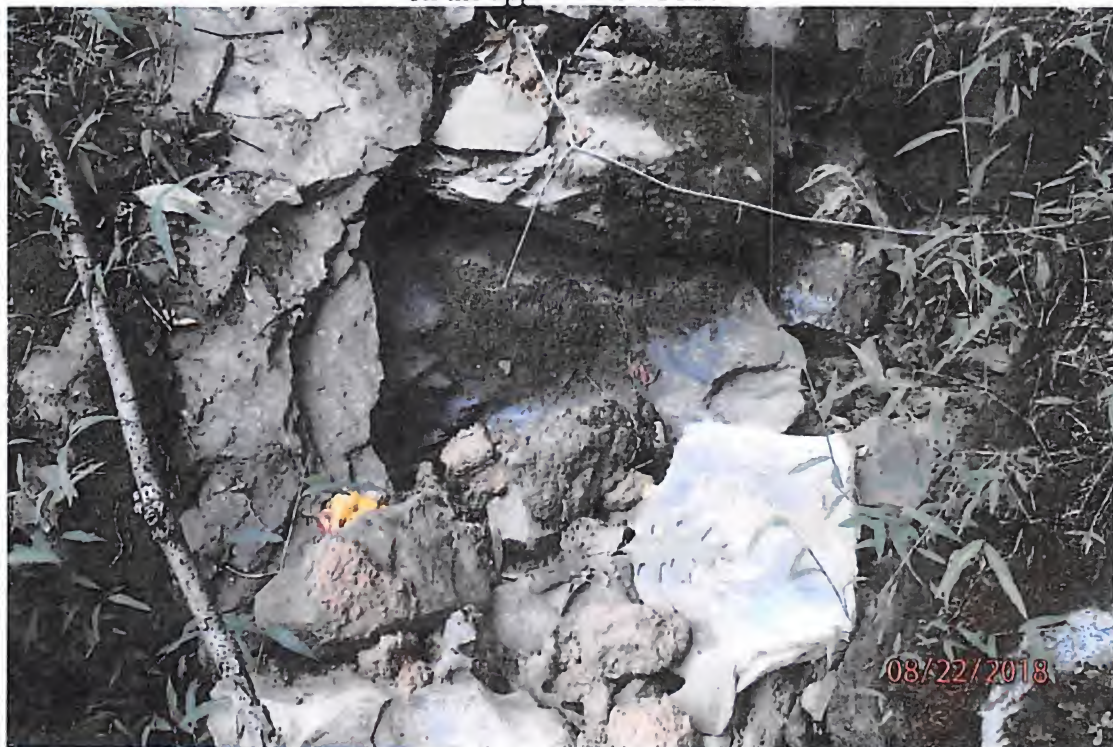
CNA deposits in UNT Flint Run (UNT 94 near 272+00) ($39^{\circ} 20.051'$ X $80^{\circ} 39.945'$).

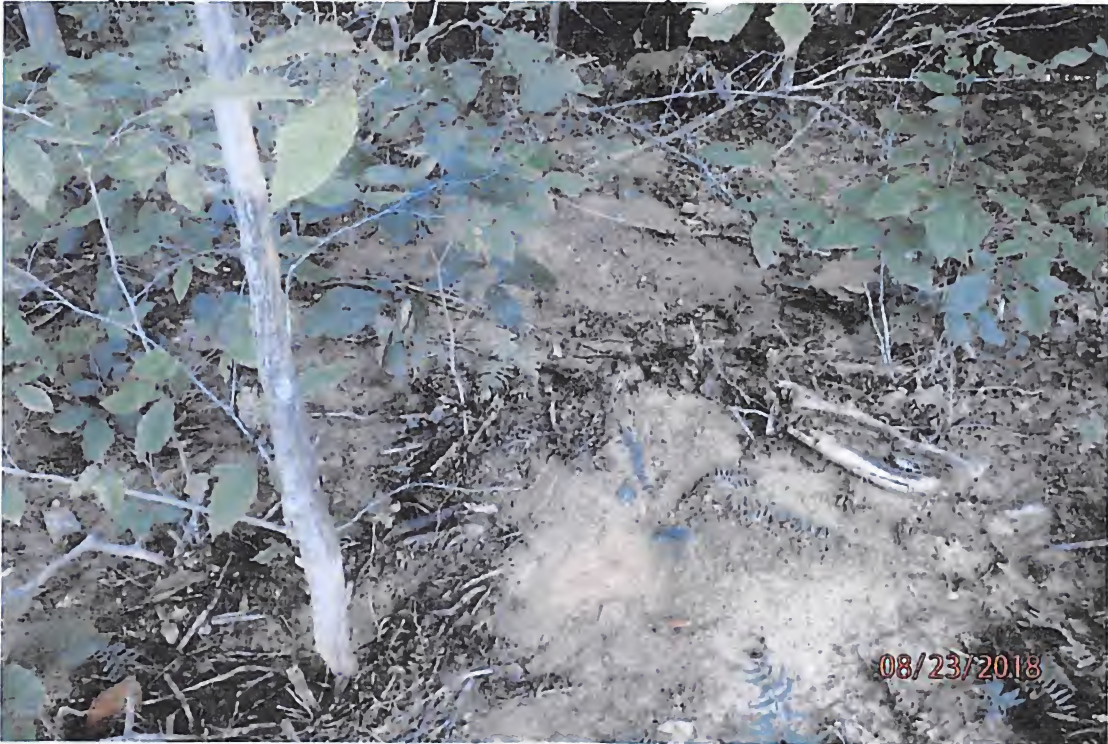
Offsite sediment deposits that lead to the receiving stream as a result of the above pictured deficiency.

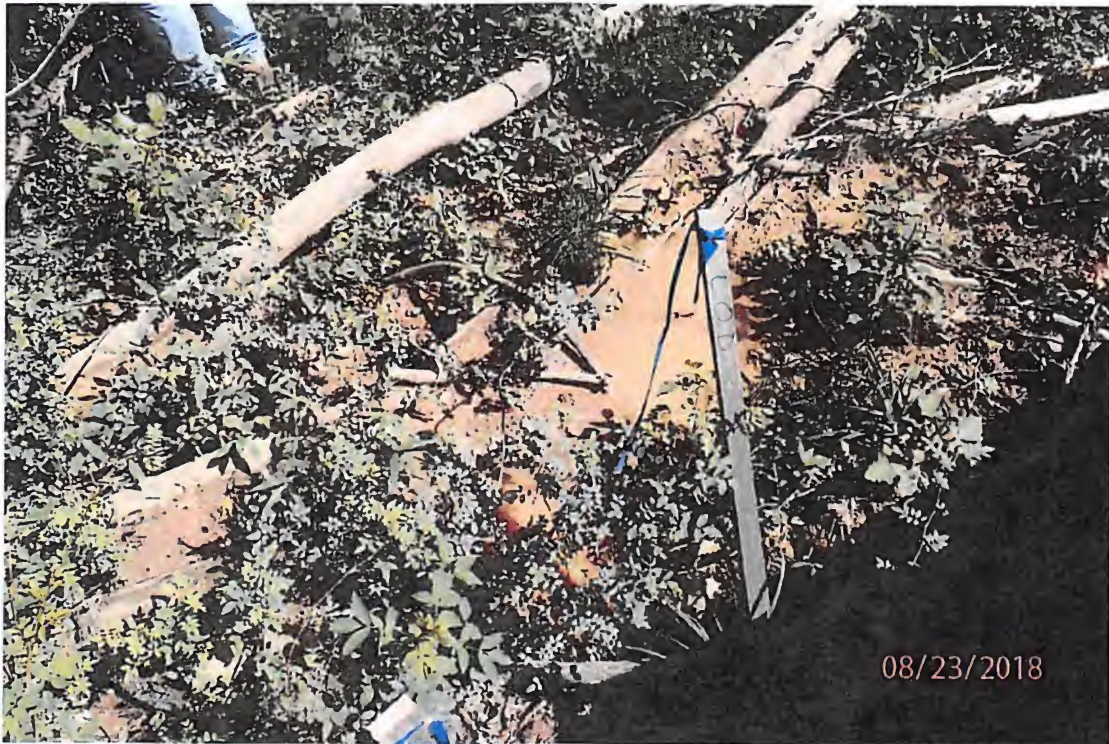
Offsite sediment deposits that lead to the receiving stream as a result of the above pictured BMP.

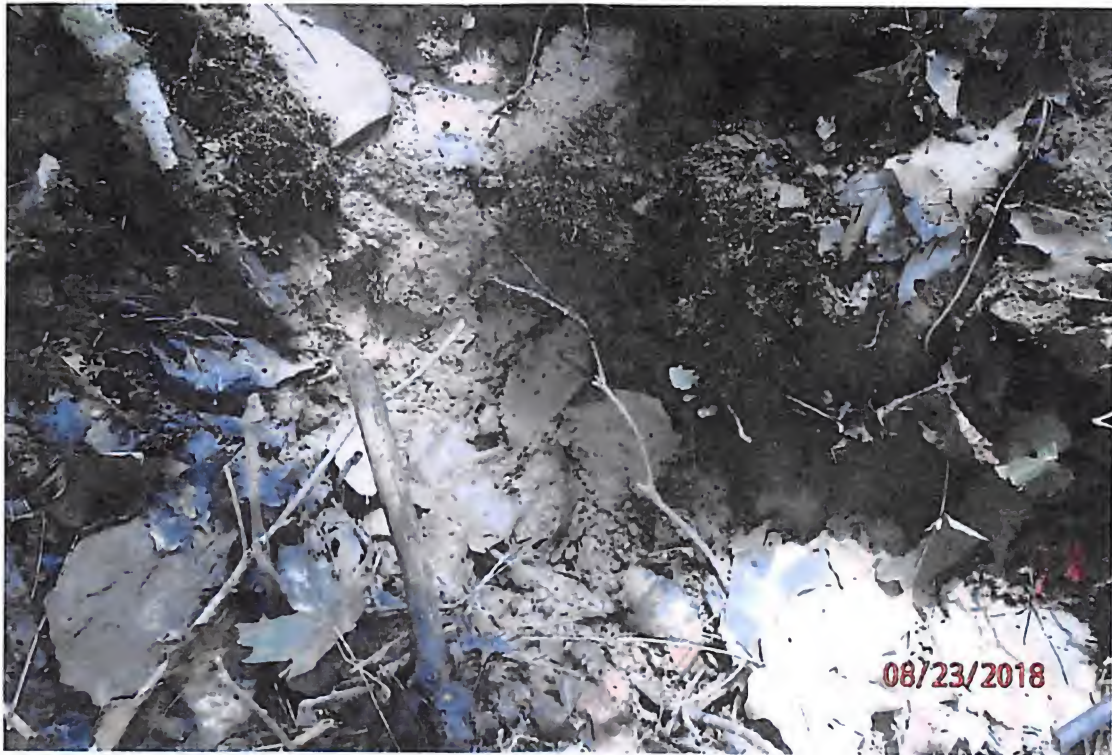
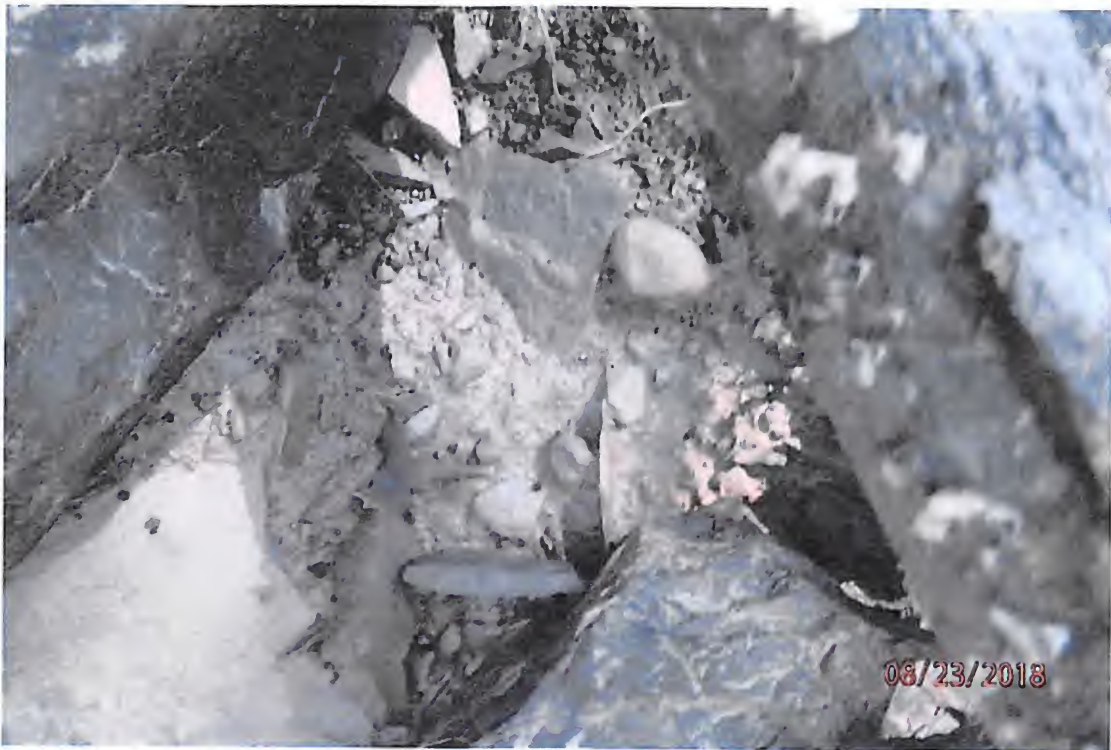
Offsite CNA deposits in UNT Franks Run (Adjacent to 798+60) (39° 26.011' X 80° 36.969') resulting from the previously pictured deficiency.

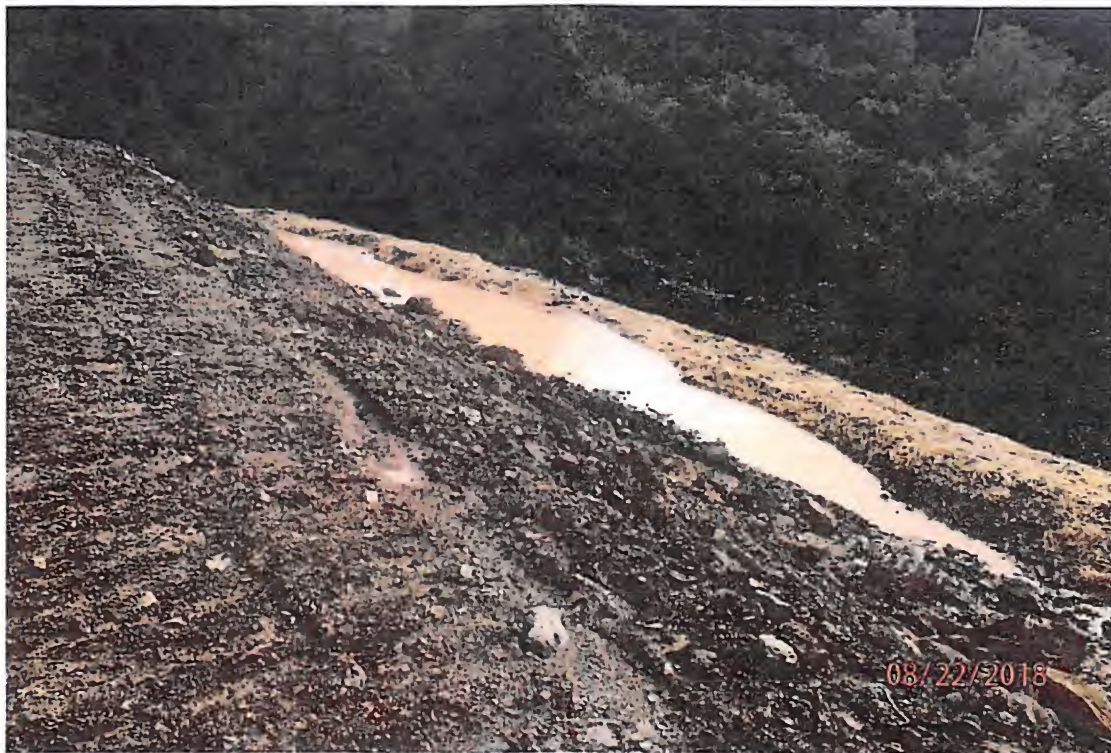
Installed diversion berm in the Morgans Run watershed that lacks adequate outlets.

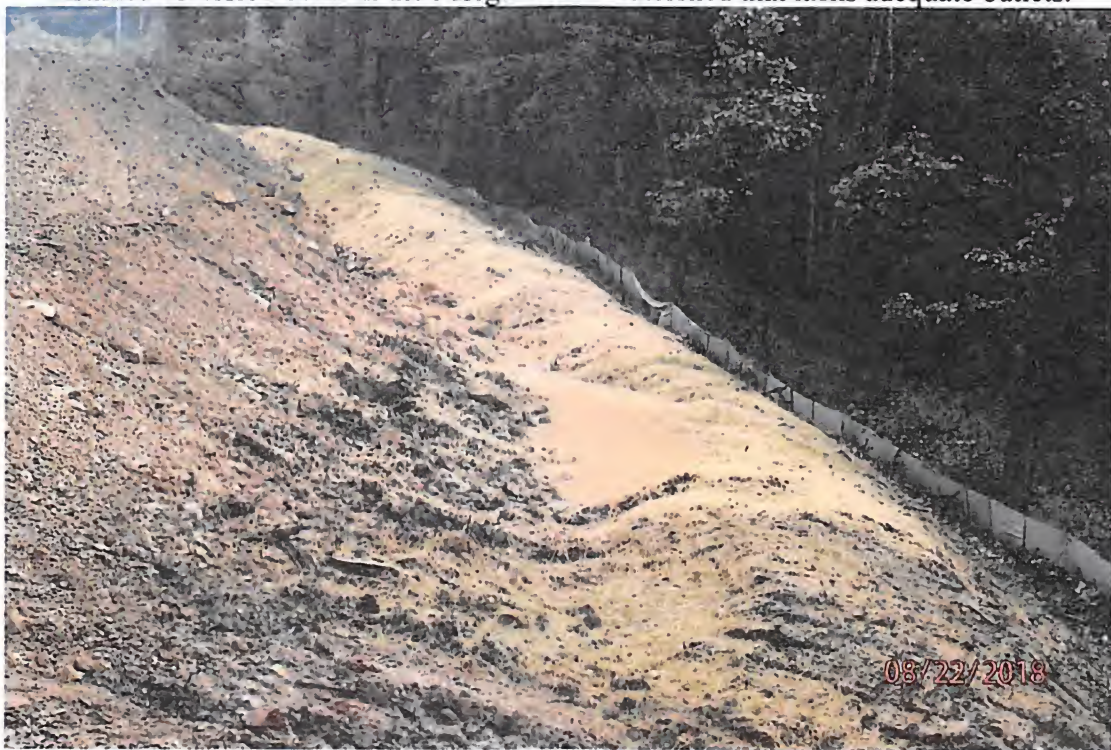
Installed diversion berm in the Morgans Run watershed that lacks adequate outlets.

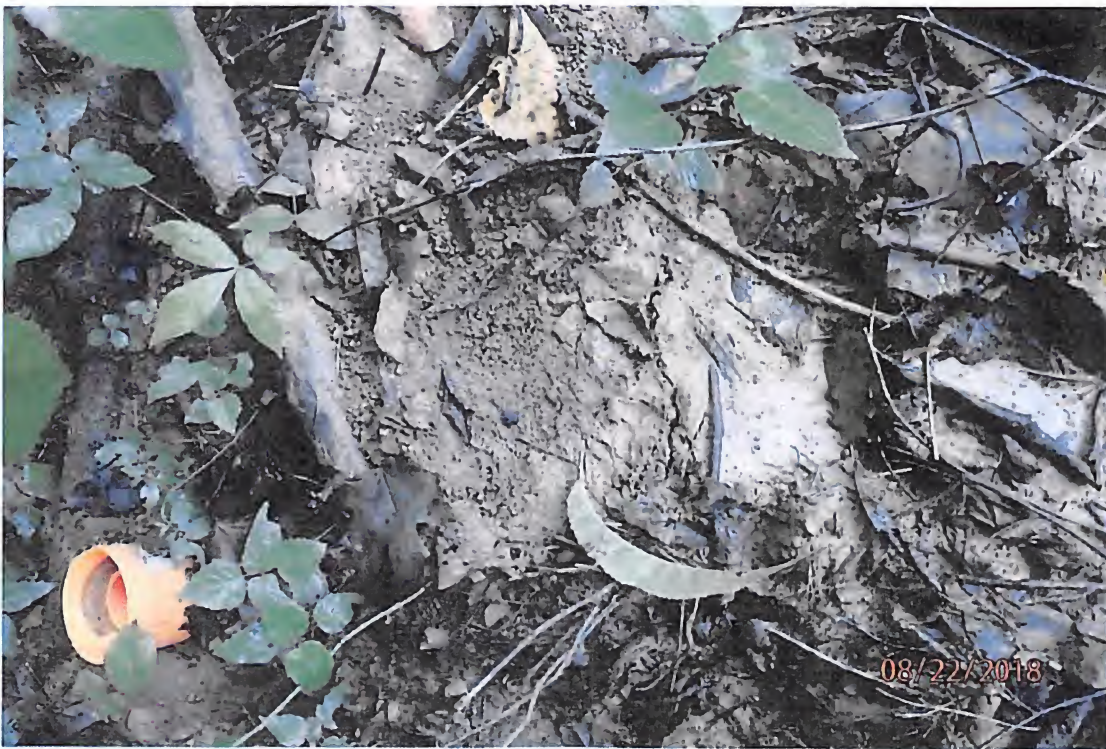
Offsite CNA deposits in UNT Morgans Run (39° 17.638' X 80° 40.727') as a result of the previously pictured BMP.

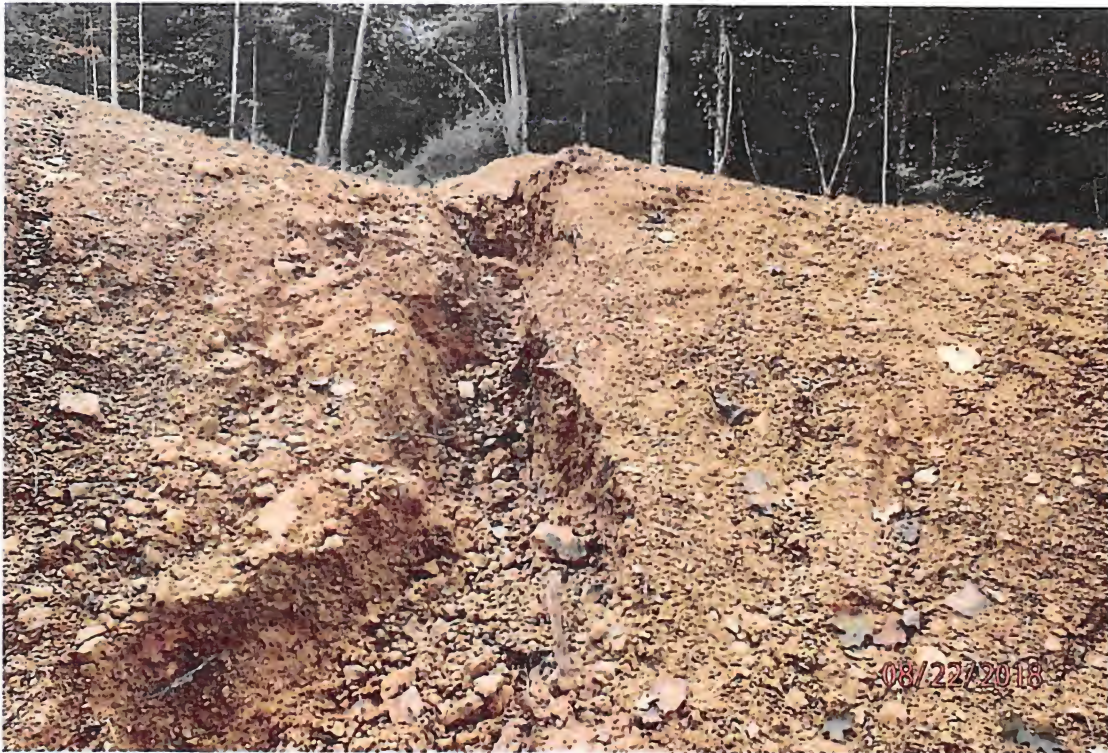
Fill slope erosion adjacent to UNT 108 as a result of concentrated flow from a water bar outlet.

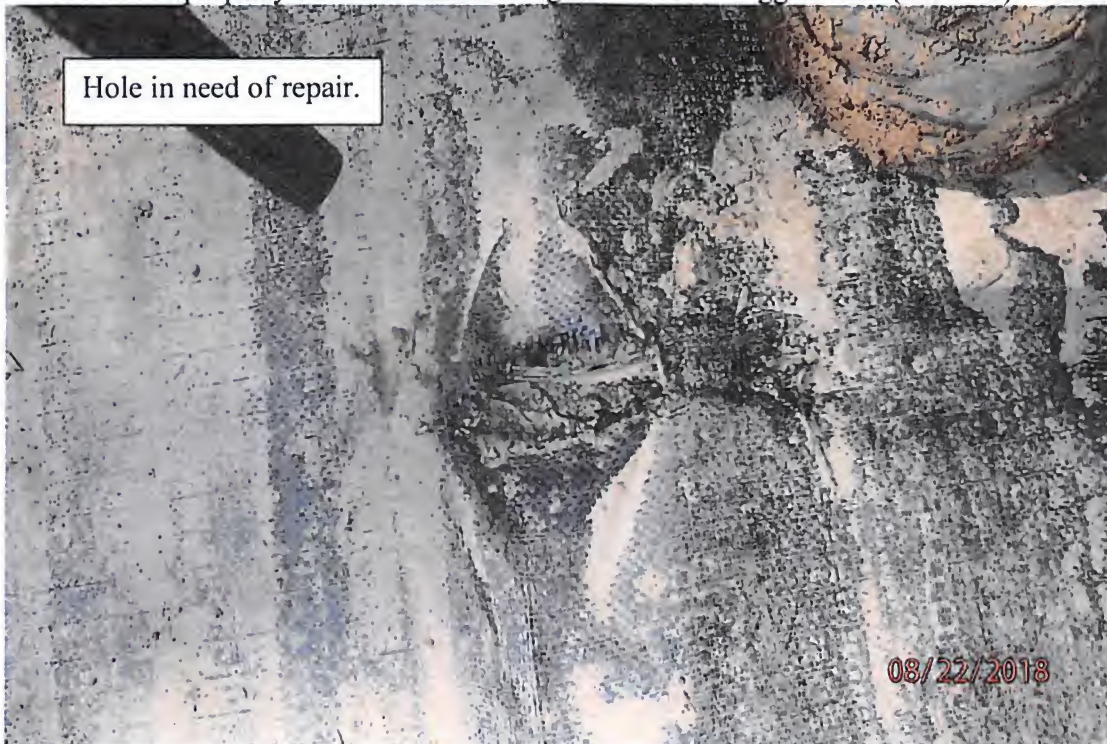
Picture showing maintenance need as a result of the improperly constructed bridge at the UNT Riggins Run (UNT 98) crossing.

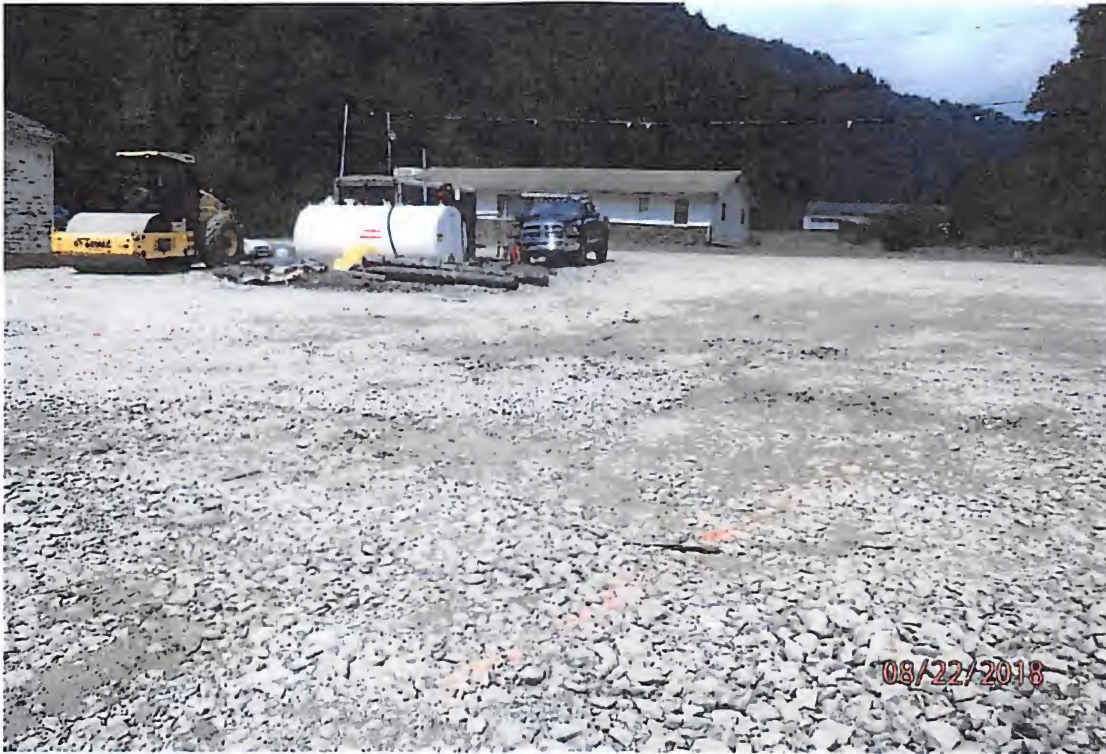
Overview of construction work associated with the project that is located off LOD near 277+00.

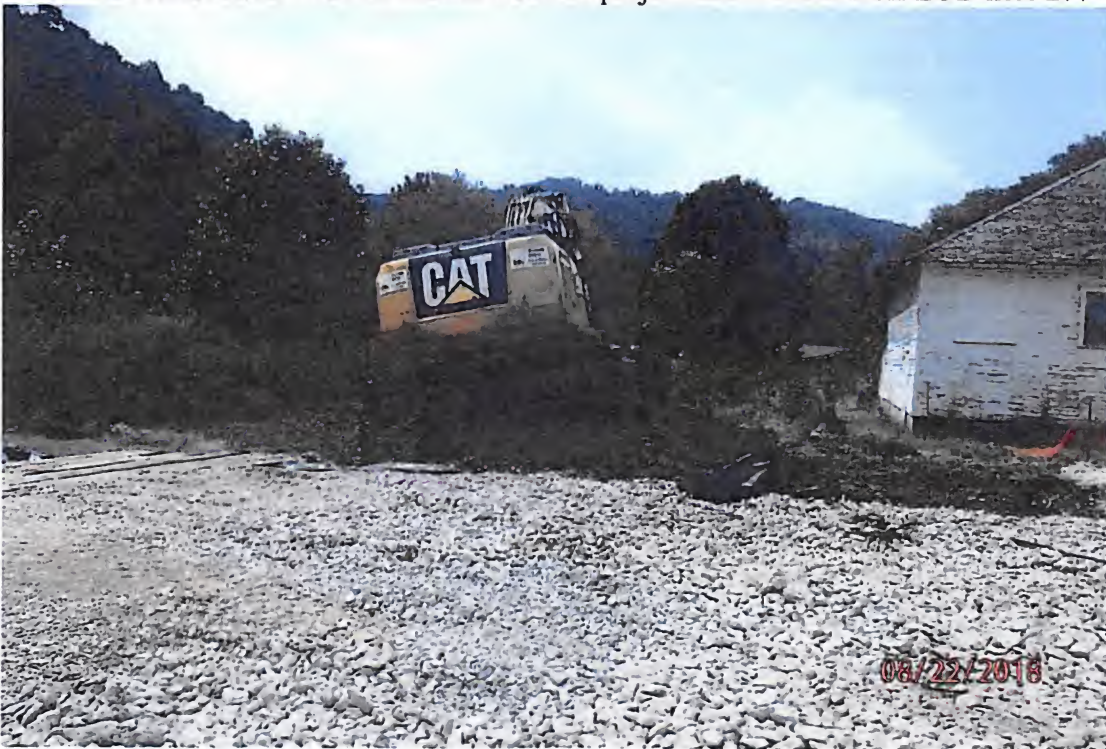
Overview of construction work associated with the project that is located off LOD near 277+00.

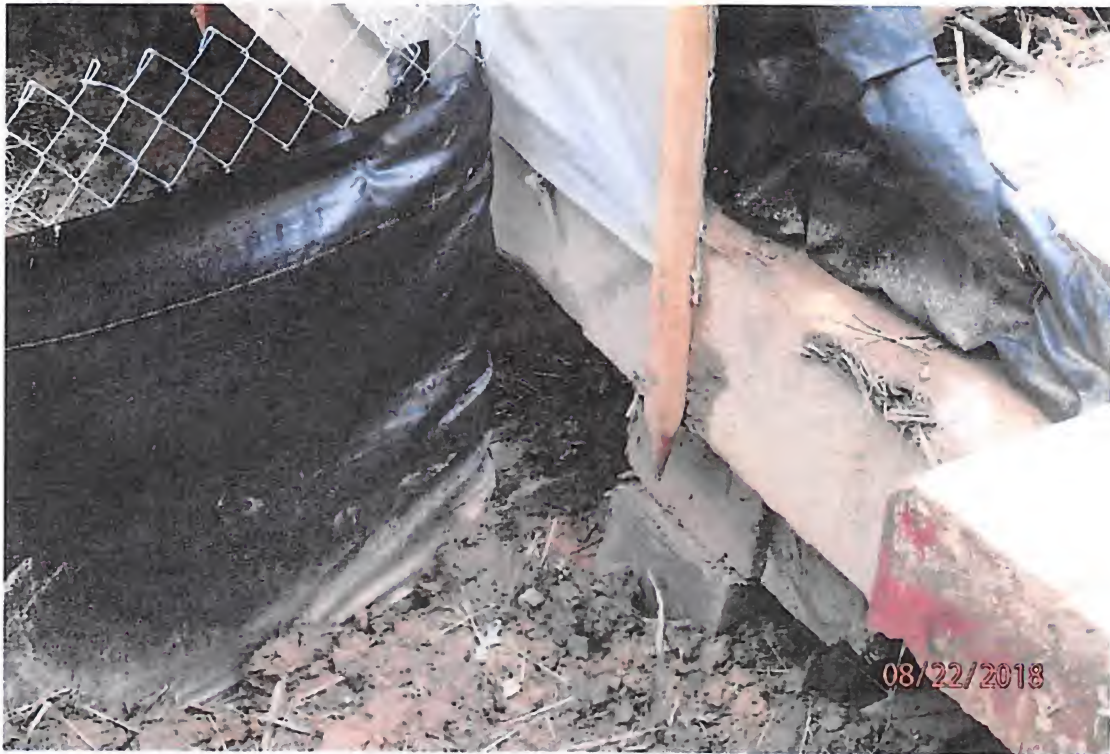
Installed timber mat bridge at crossing 41 (UNT 18) that is not tied in properly.

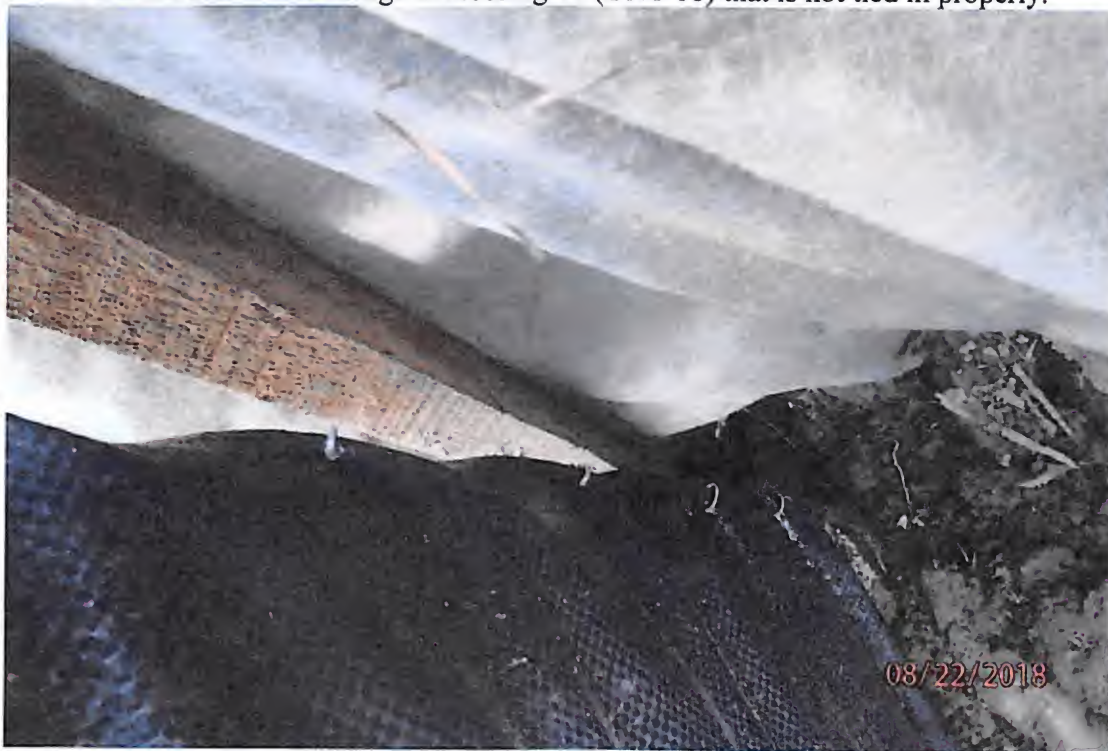
Installed timber mat bridge at crossing 41 (UNT 18) that is not tied in properly.

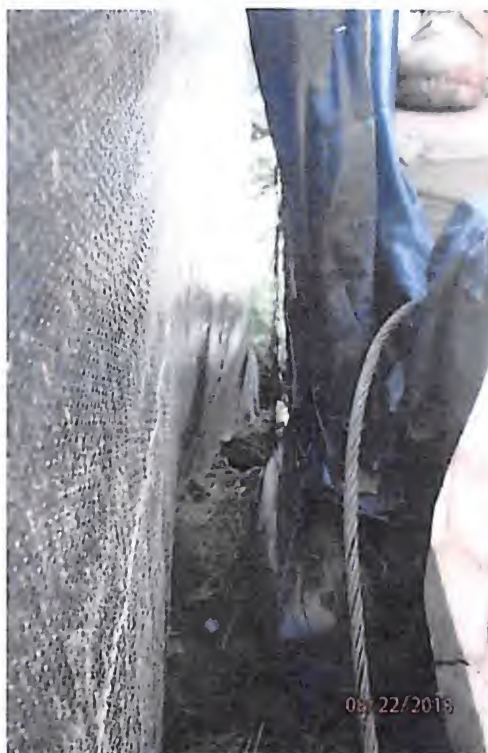
Installed timber mat bridge at crossing 43 (Riggins Run) that is not tied in properly.

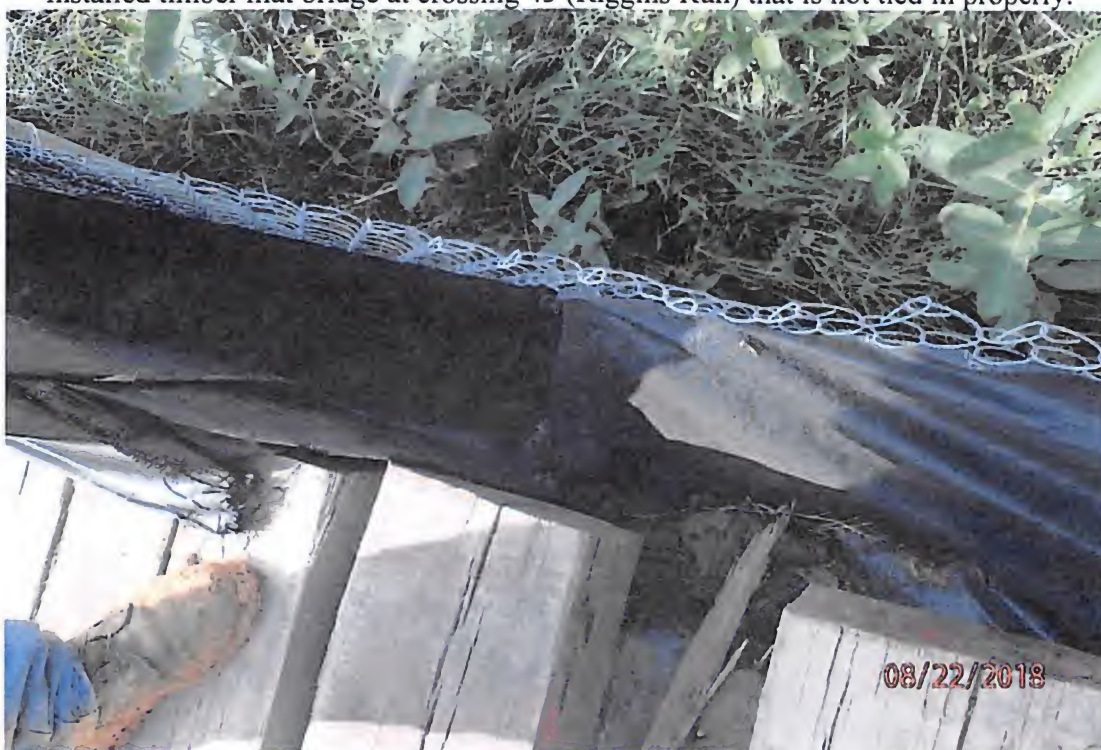
Installed timber mat bridge at crossing 43 (Riggins Run) that is not tied in properly.

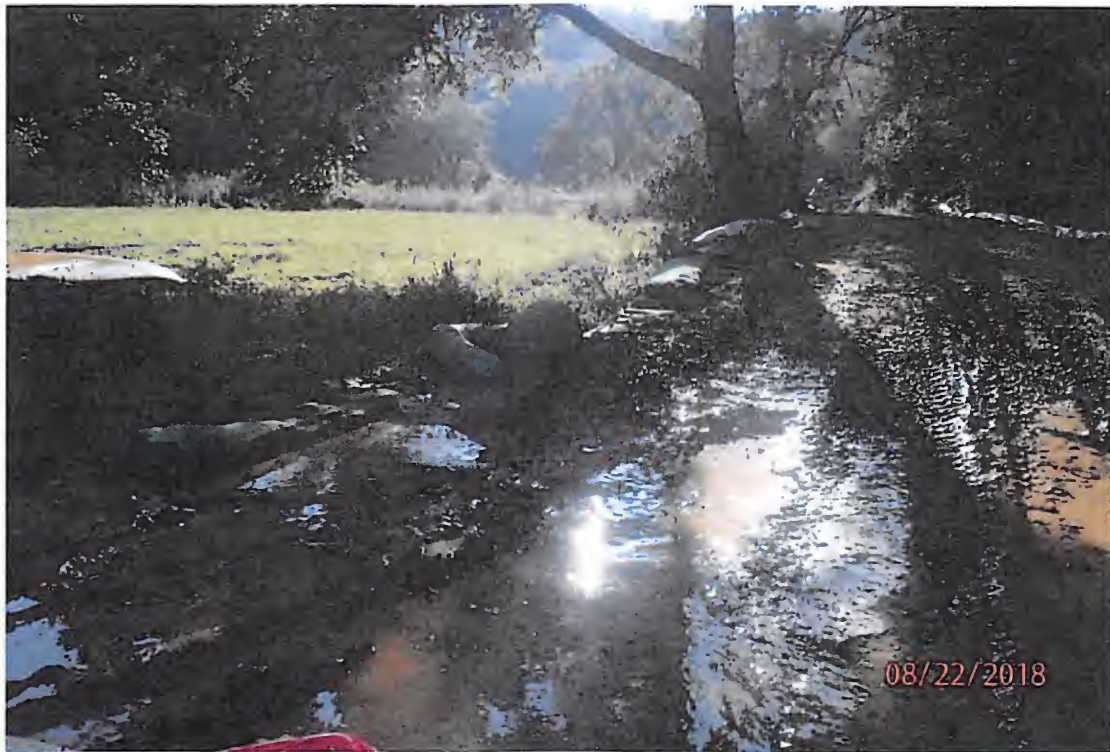
AR 40 showing a lack of stabilization that is described in the approved SWPPP.

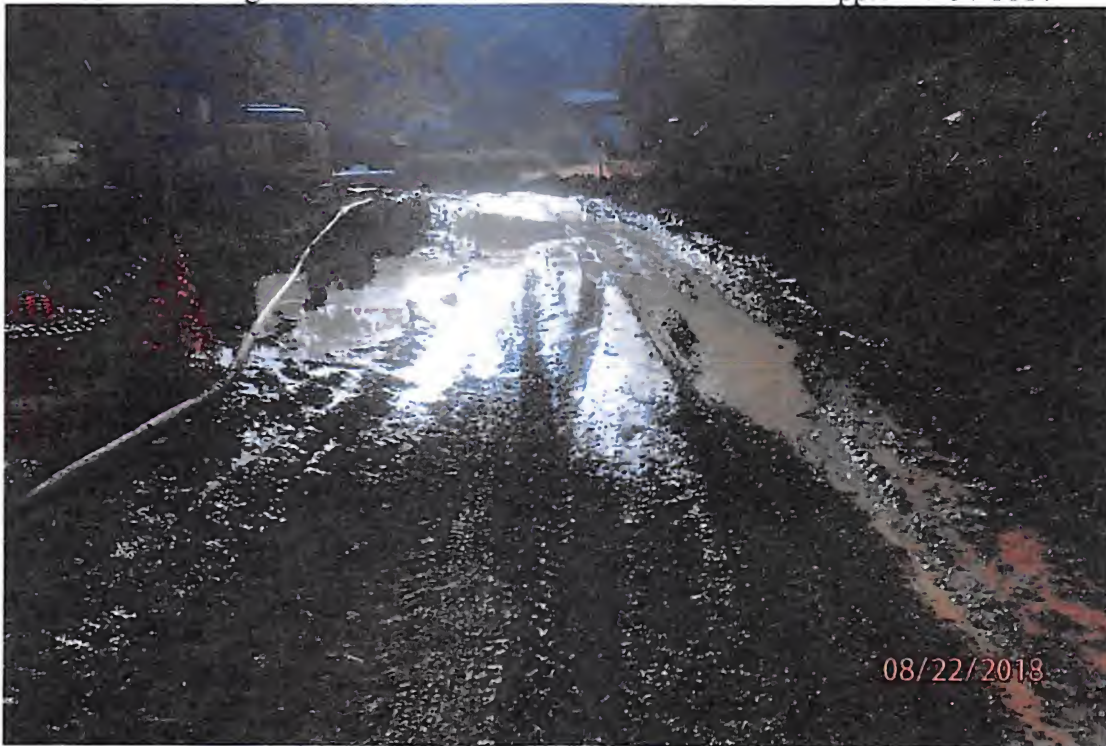
AR 40 showing a lack of stabilization that is described in the approved SWPPP.

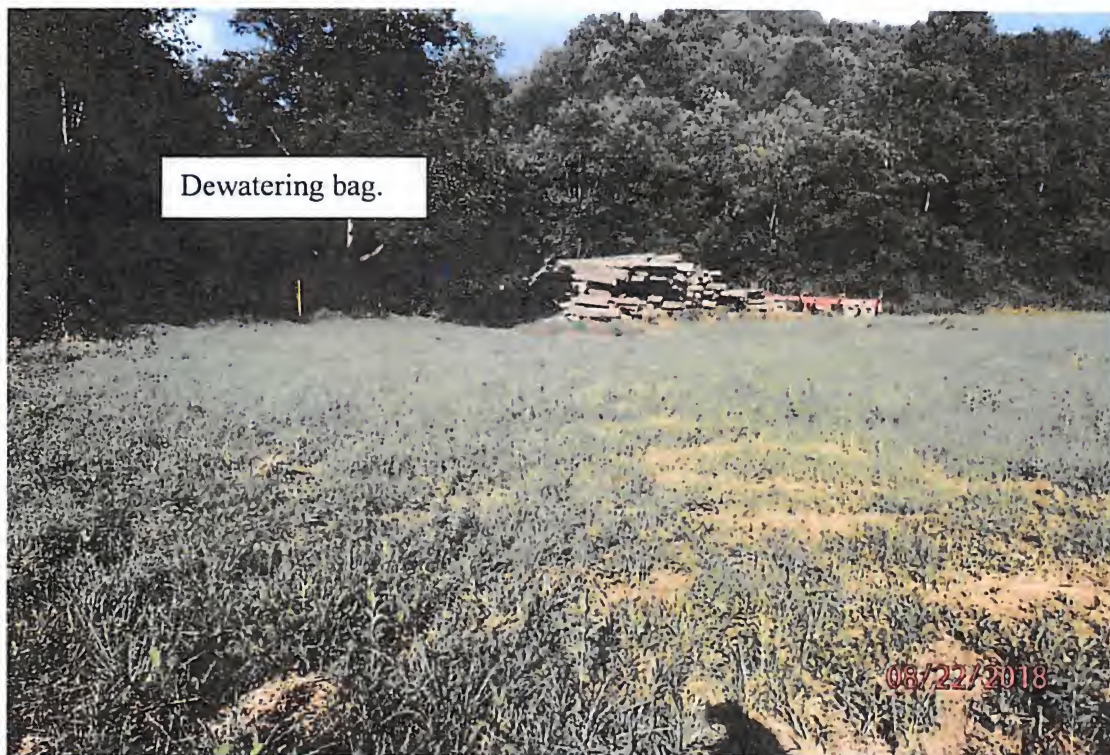
Overview of dewatering BMP adjacent to UNT 127.

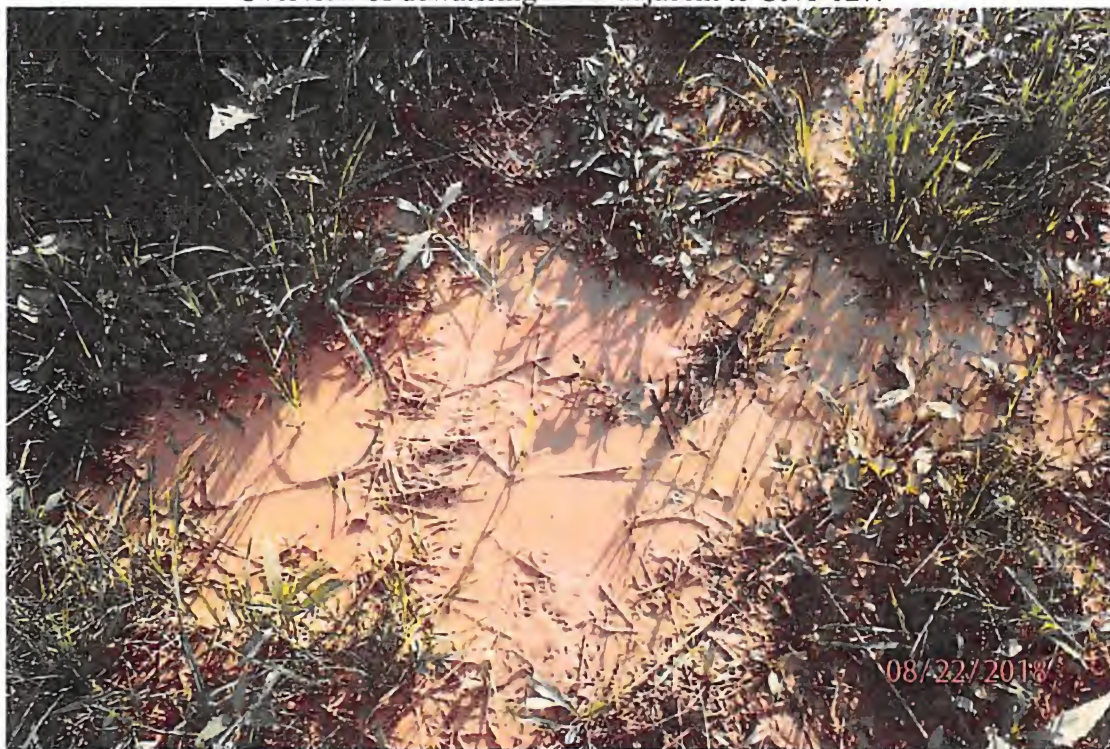
Offsite sediment trail leading from the dewatering bag to the receiving stream.

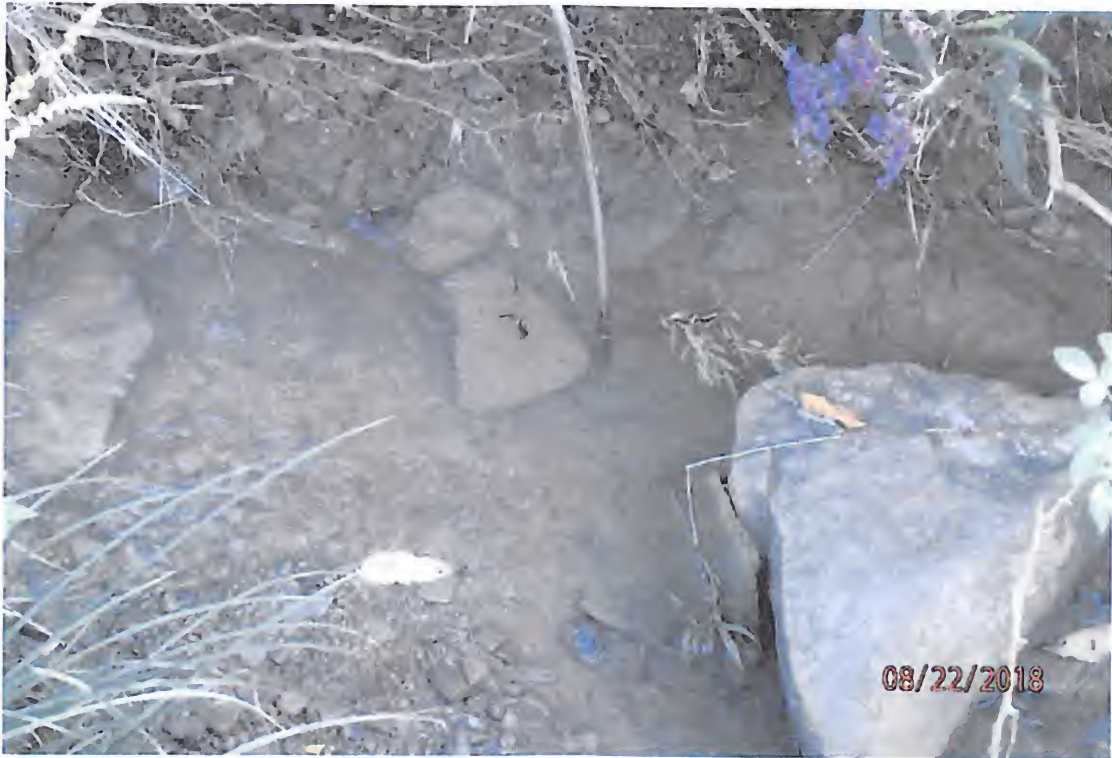
Water quality in UNT Franks Run upstream of dewatering activity.

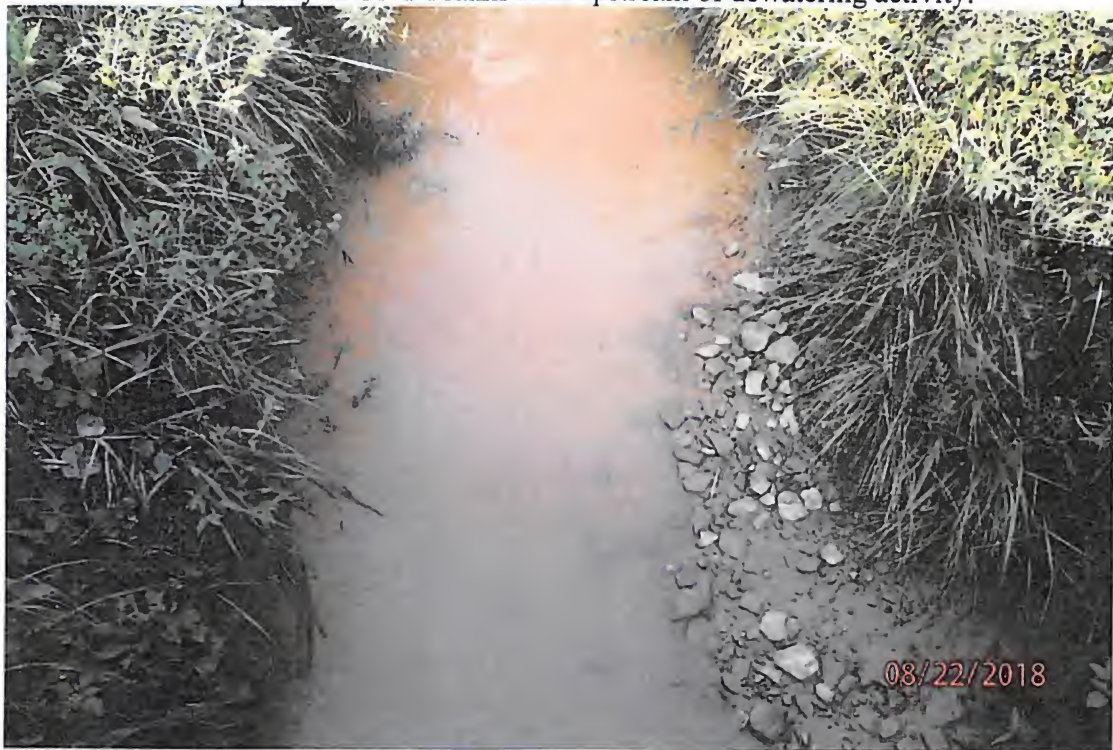
Offsite CNA deposits and distinctly visible settleable solids in UNT Franks Run (39° 26.167' X 80° 36.861') downstream of the dewatering activity.
